**A Study Of South Fork
Shenandoah Tributaries**

Rockingham County, Virginia

APPENDIX VIII

PLEASANT RUN

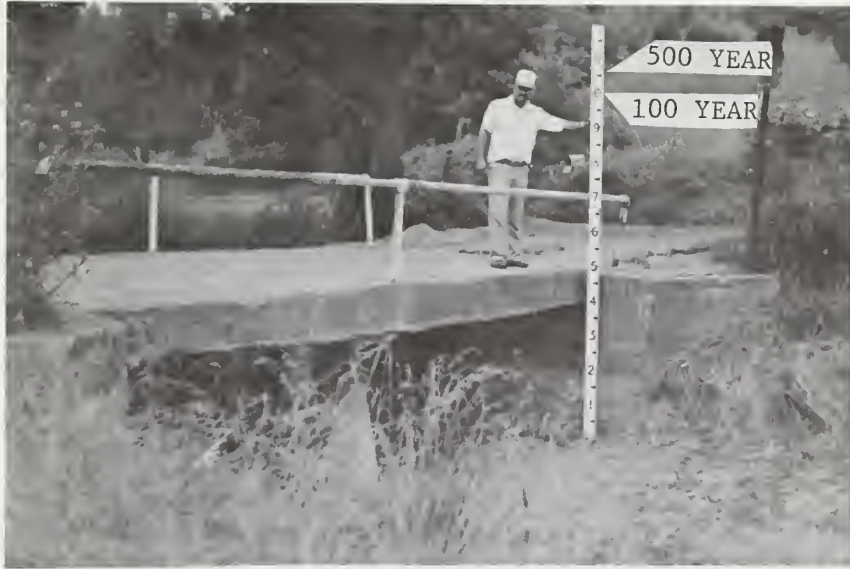
Figure 1. Potential Flood Stages at Cross-Section 74, downstream of State Route 711 over Pleasant Run.

Extreme floods would inundate about 128 acres of primarily agricultural land (see Table below). Extensive damage would be done to the land, crops, fences, farm roads, buildings and machinery. Less extensive but more critical damage would accrue to dwellings. Velocities would average about three feet per second and exceed five feet per second in some reaches. Out-of-bank stages would range from about three to sixteen feet. Duration of flooding would seldom exceed six hours except during storms of intense and prolonged rainfall. Figures 1, 2, and 3 show potential flood stages.

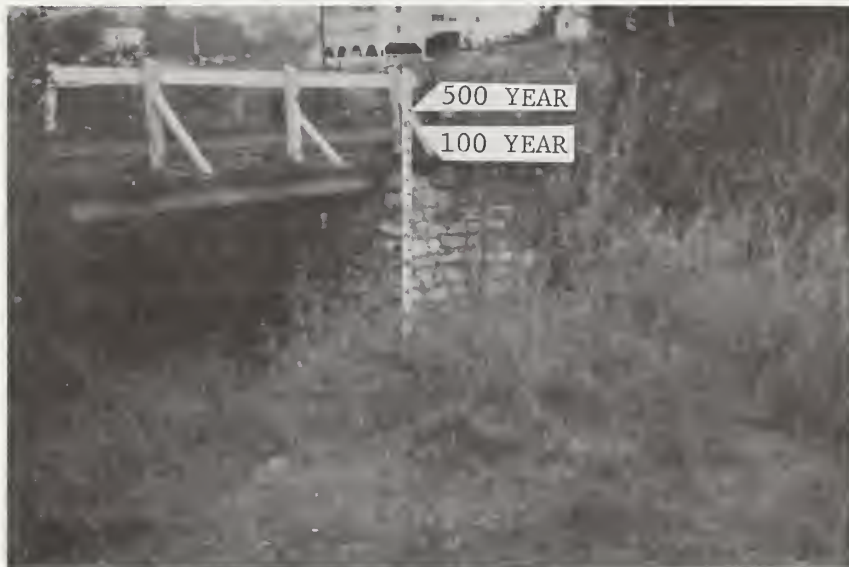
Figure 2. Potential Flood Stages at Cross-Section 78, downstream of State Route 704 over Pleasant Run.

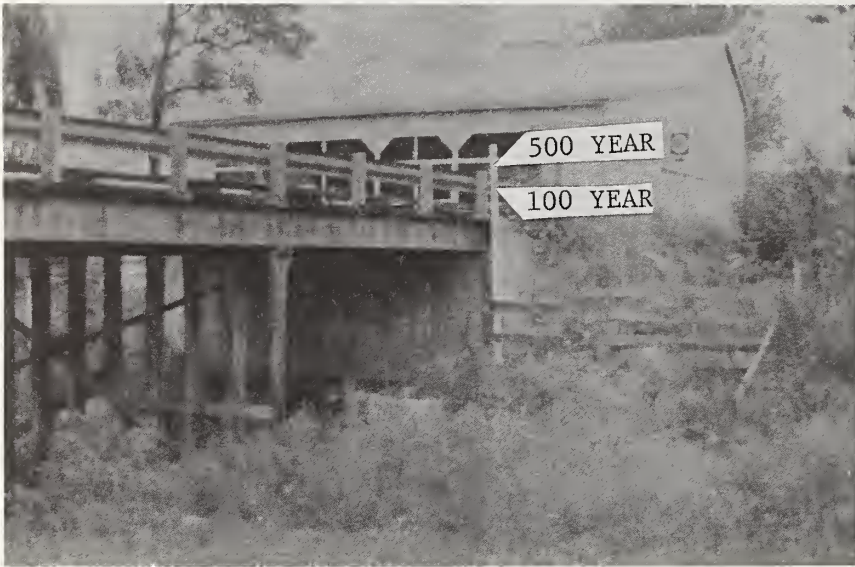
Figure 3. Potential Flood Stages at Cross-Section 96, State Route 257 over Pleasant Run.

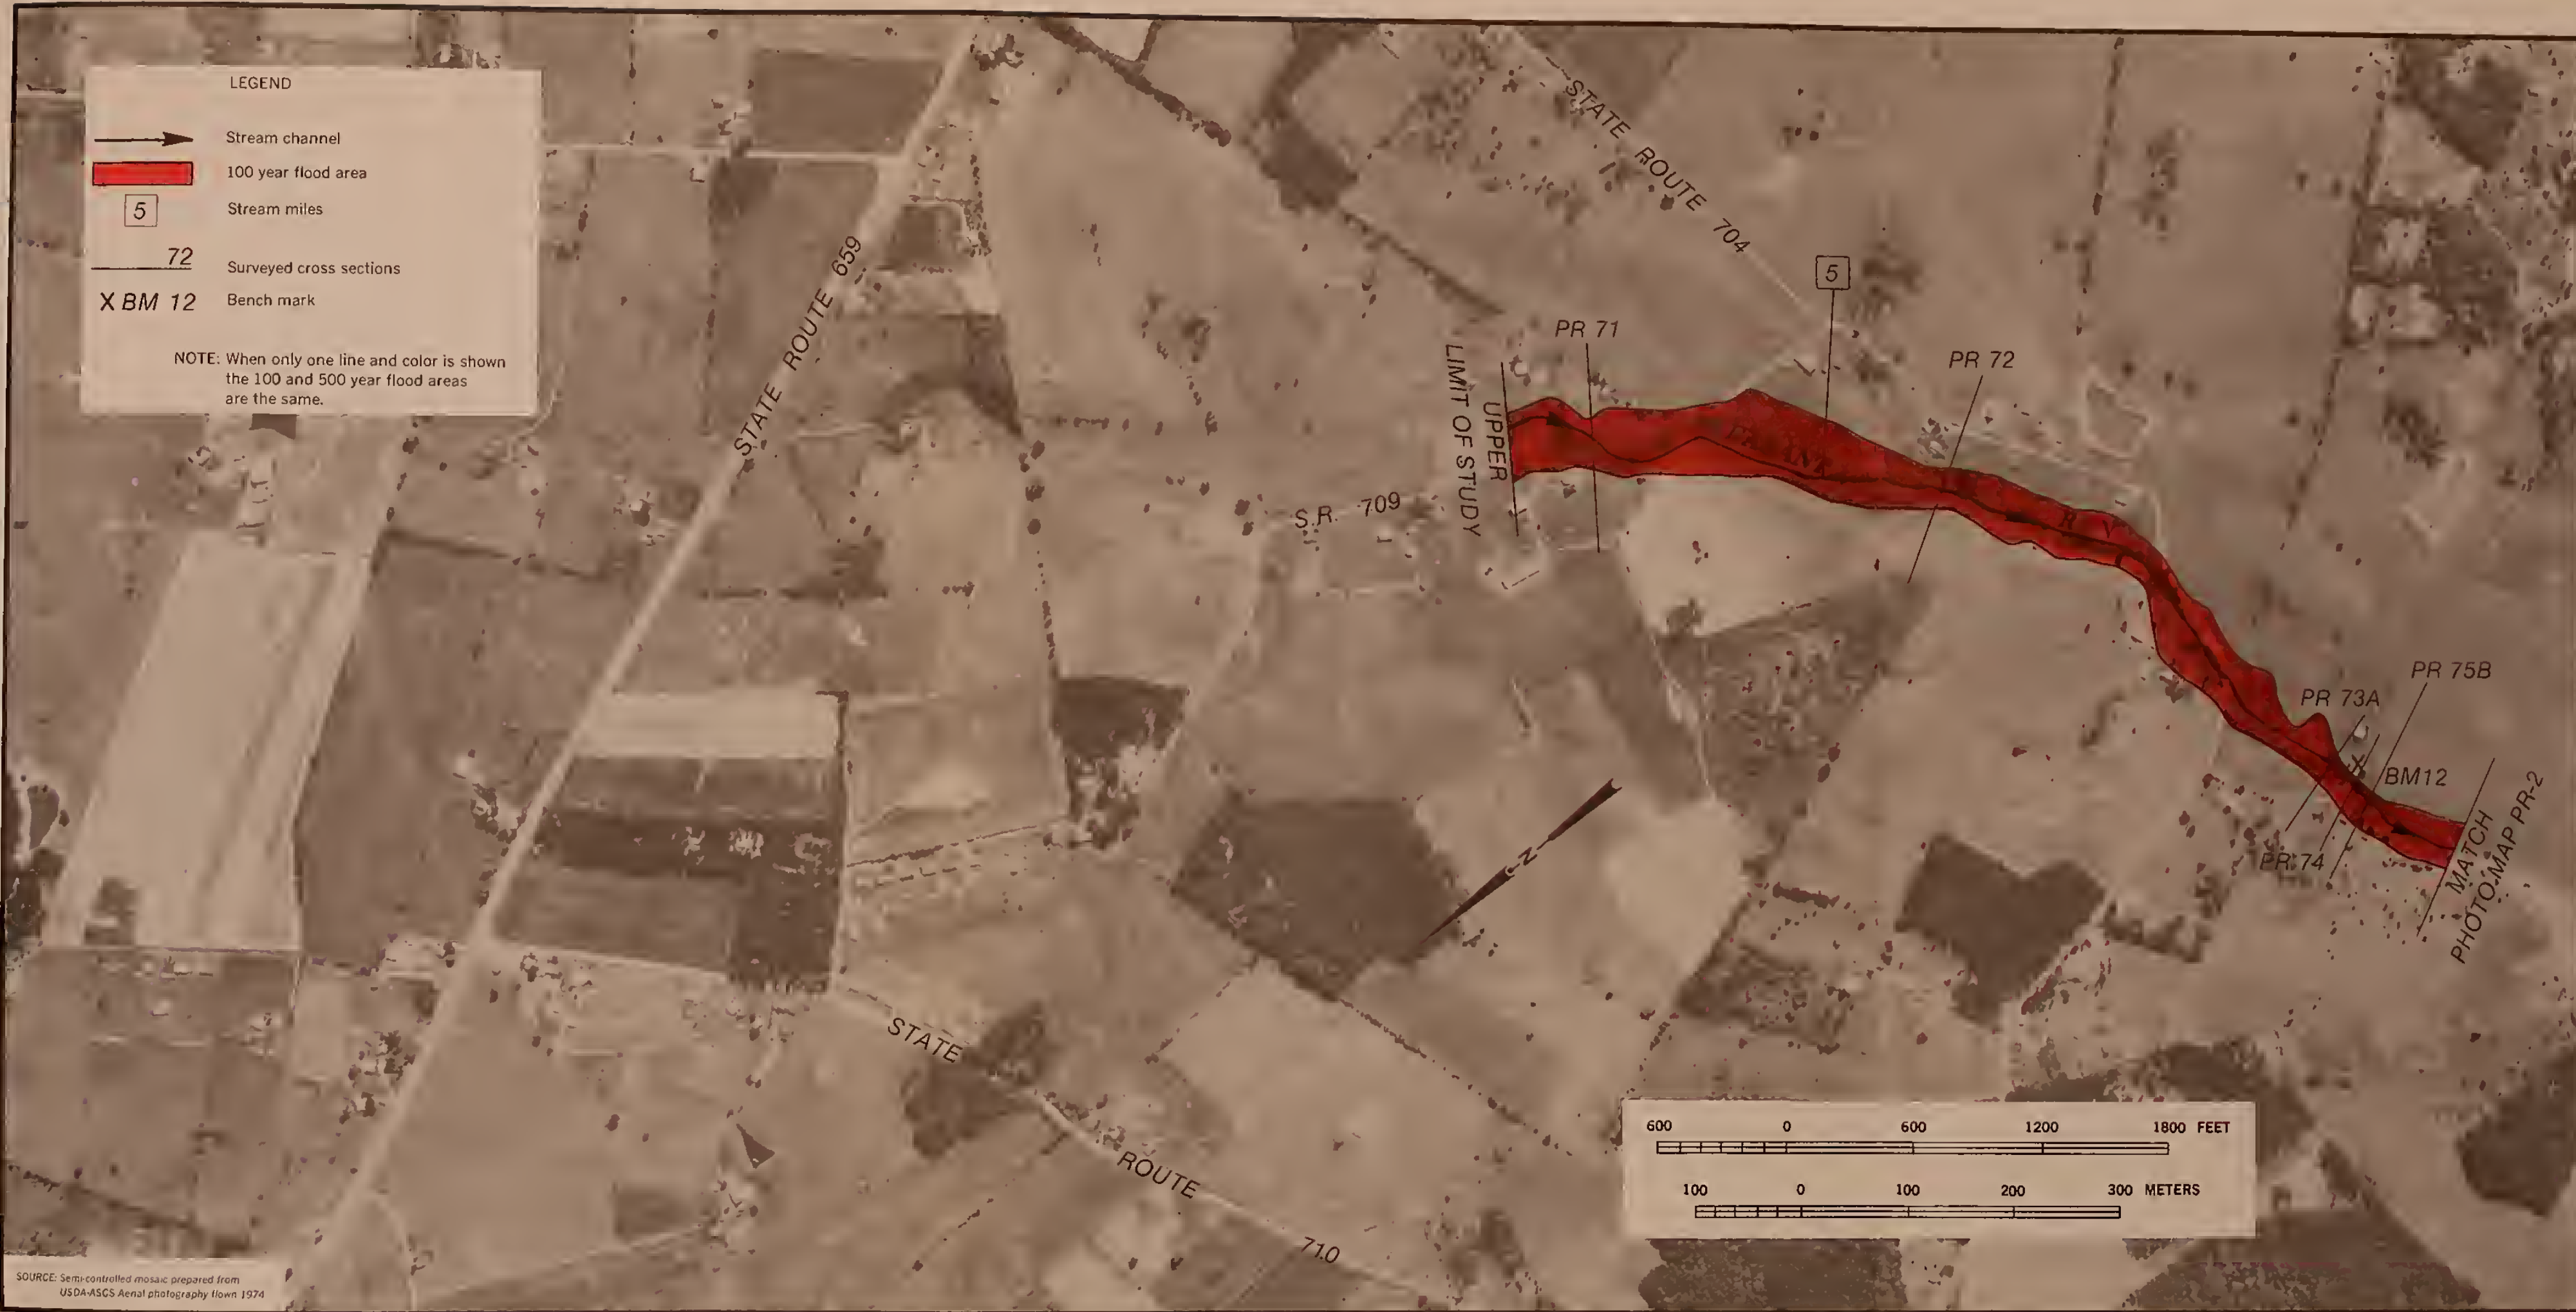
PHOTO MAP PR 1

The index map shows the area covered by the individual photomaps. Flood hazard photomaps show the area inundated by the 100 and 500-year floods. Where only one line is shown, there is no significant difference in the boundaries of the two flood areas. These photomaps should only be used to determine approximate flood elevations; they are based on semicontrolled mosaics and the boundaries shown may vary from the location on the ground.

1. On the appropriate photomap find the point on the stream where the flood line is to be located; then scale the distance along the stream to the nearest cross section.
2. On the appropriate flood profile sheet, scale the distance determined in Step 1 from the cross section back to the original stream location, and read the elevation of the desired flood frequency line.
3. Transfer the elevation determined in Step 2 to the ground from the nearest established benchmark.

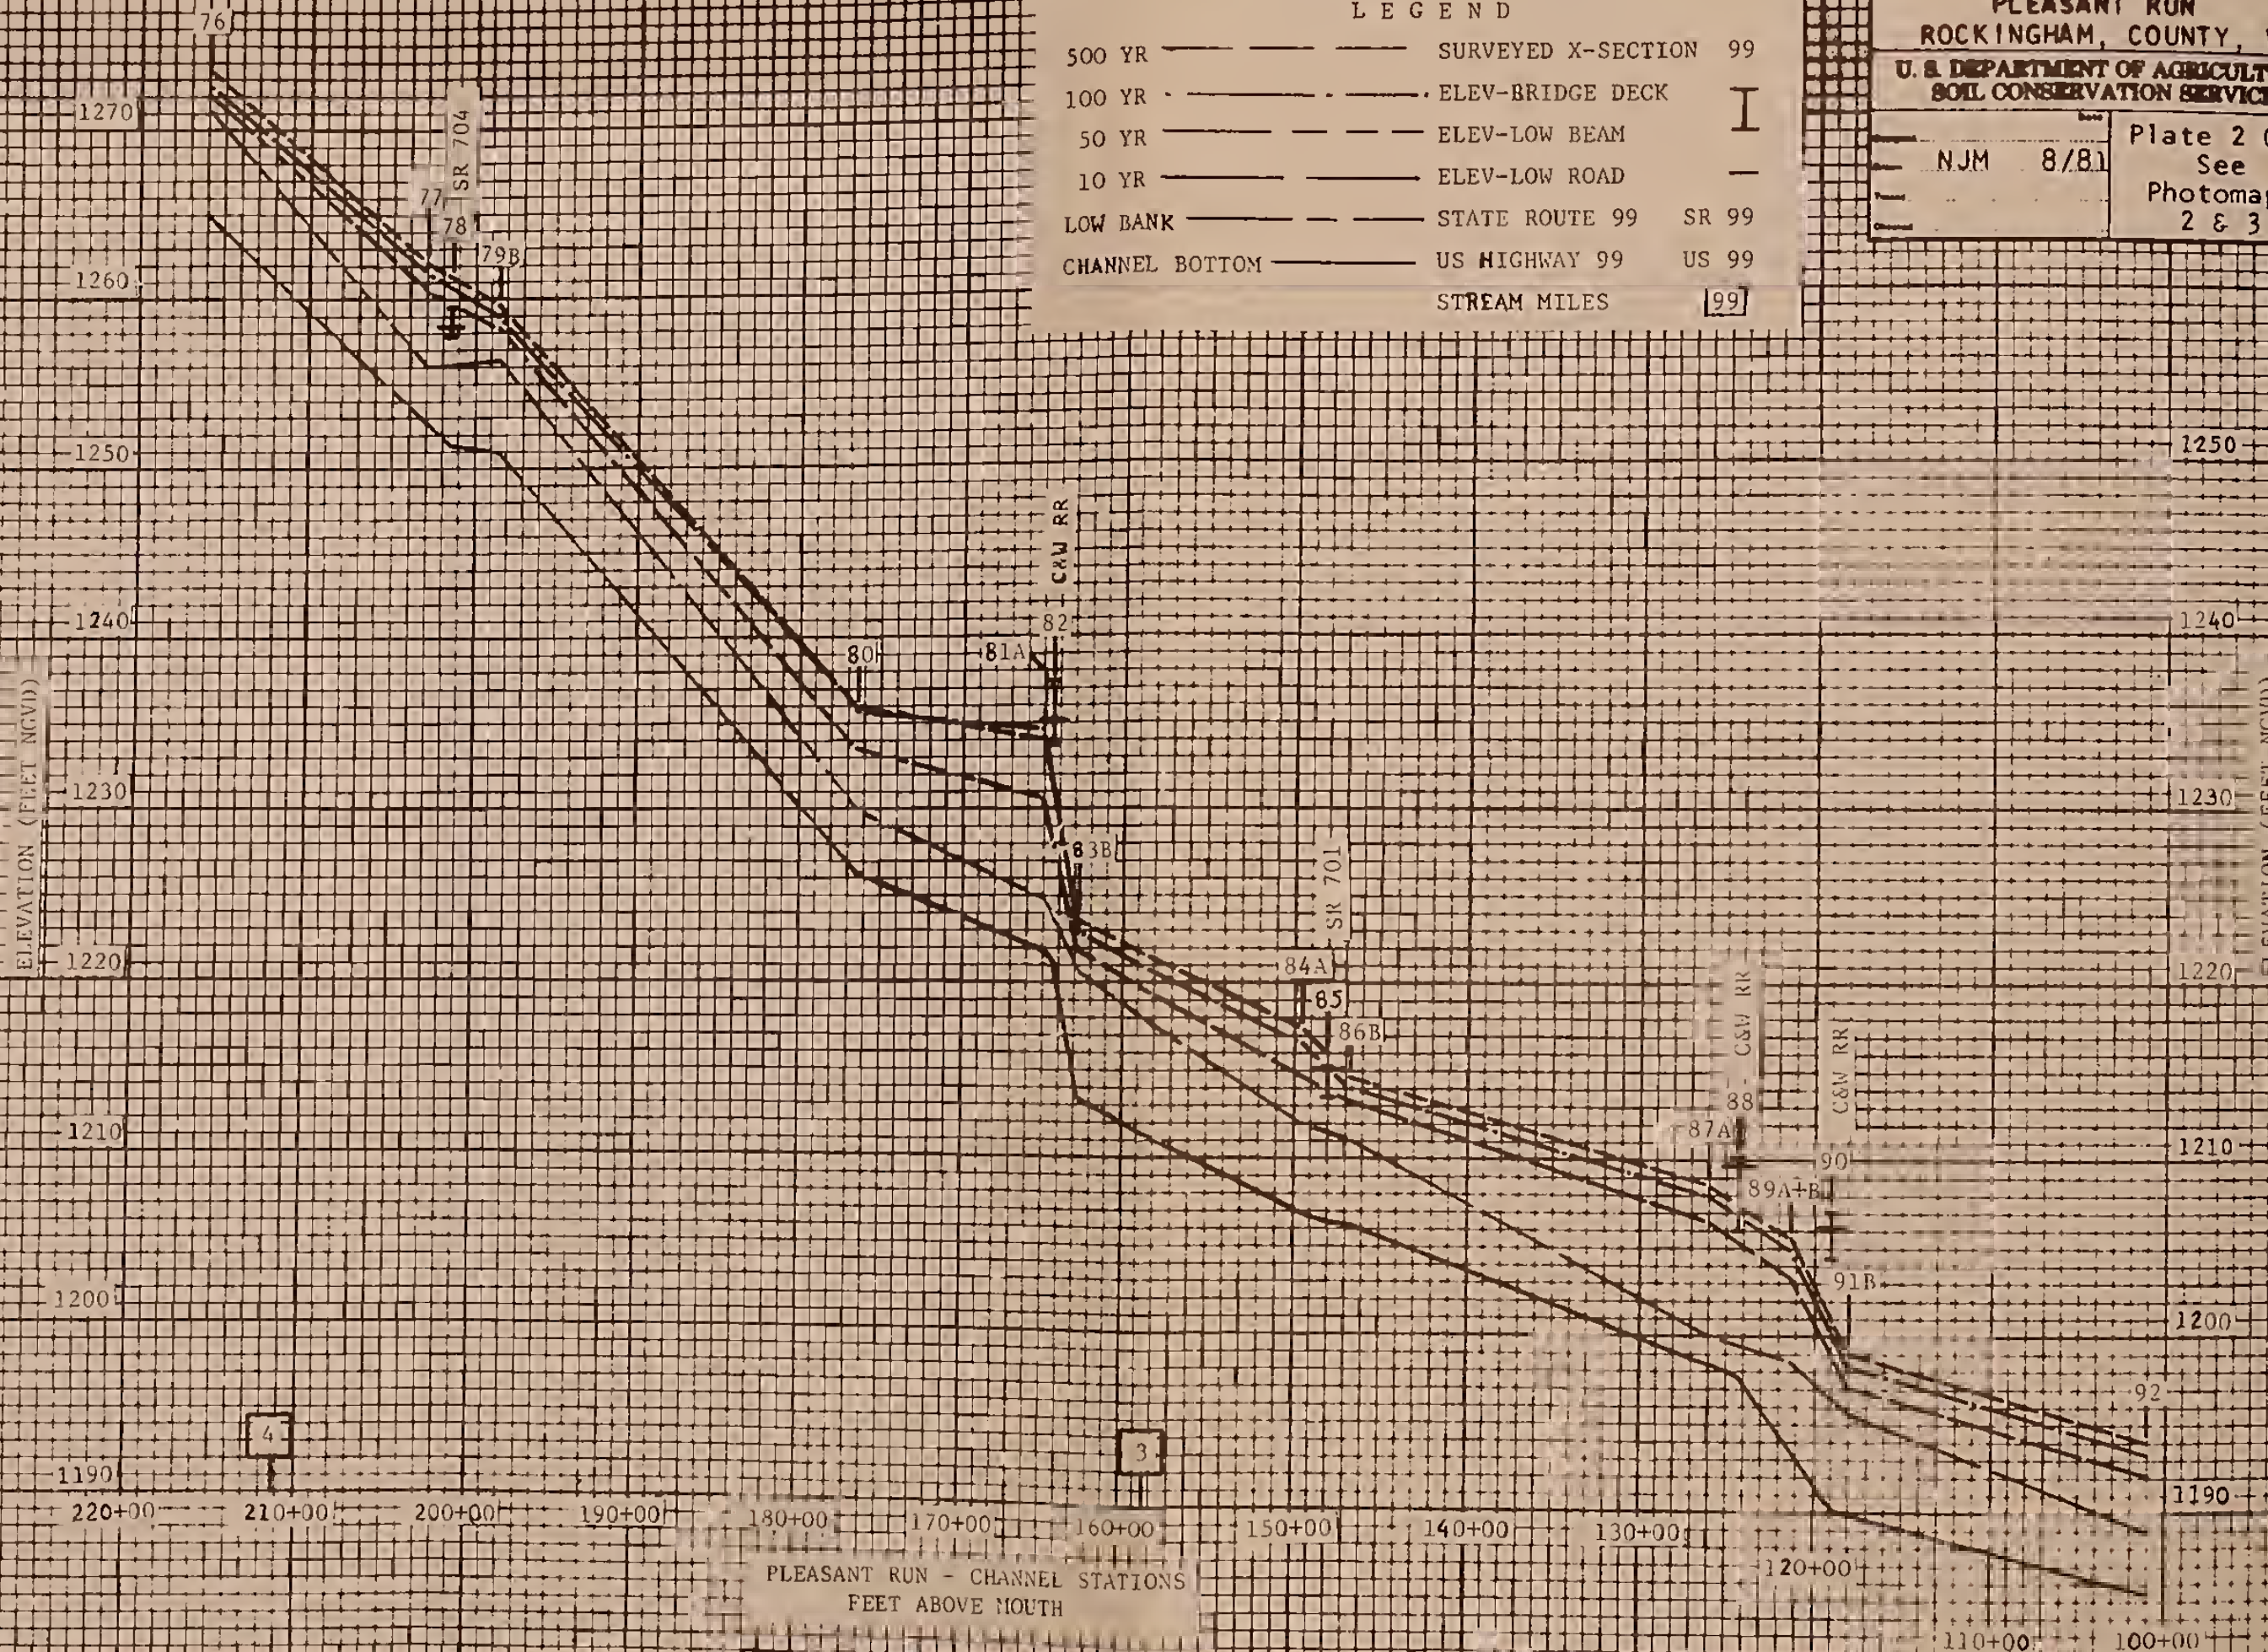
Plate 2 of 3
See
Photomaps
2 & 3

FLOOD PROFILES

Flood profile plates provide elevations of the 10, 50, 100 and 500-year floods at any location along the length of the streams. The elevations and discharges of the 10, 25, 50, 100 and 500-year flood at each surveyed cross section are given in Table PR-1. Sample cross sections illustrated how the flood area boundaries were located. Table PR-2 provides the description and elevation of benchmarks which are located on the photomaps.

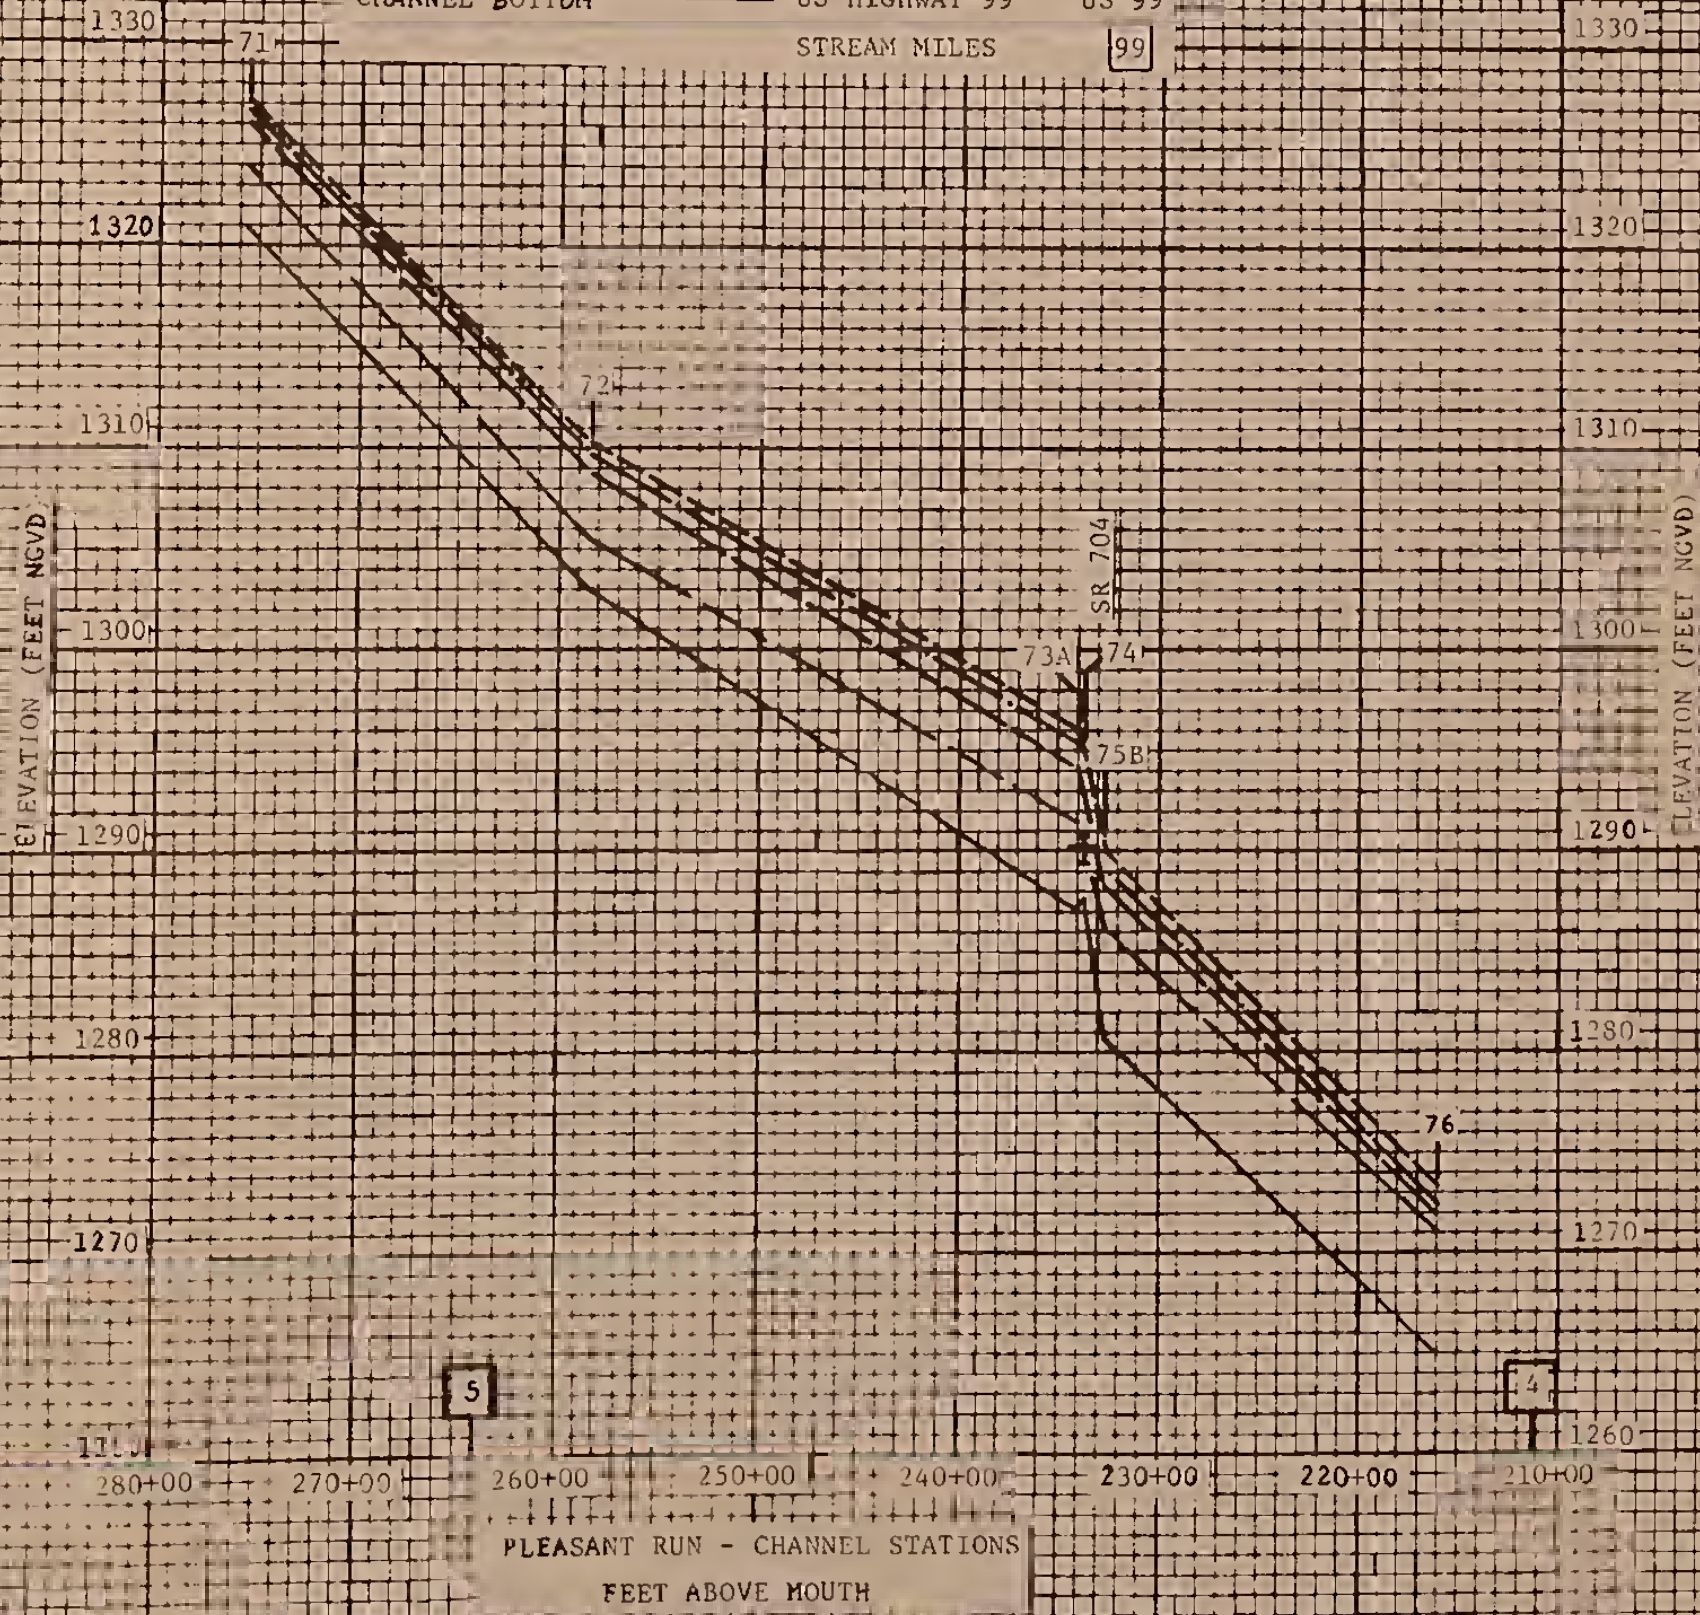
Plate 3 of 3
 See
 Photomaps
 1 & 2

FLOOD PROFILES
PLEASANT RUN
ROCKINGHAM COUNTY, VA.
U. S. DEPARTMENT OF AGRICULTURE
SOIL CONSERVATION SERVICE

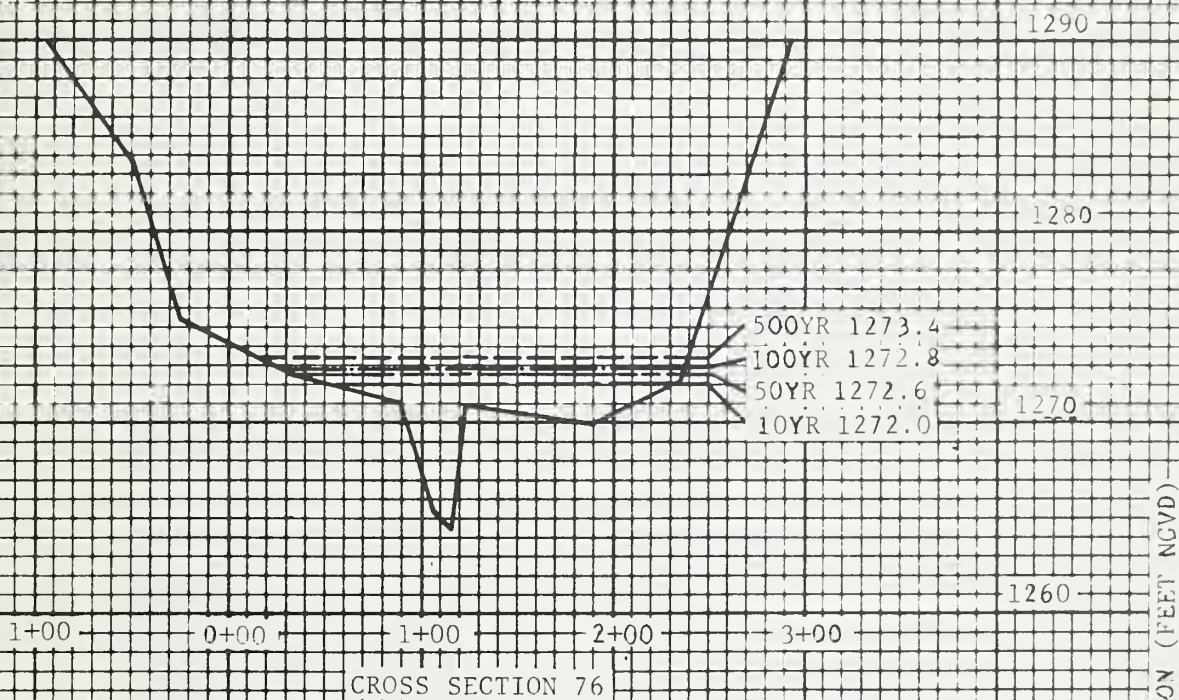
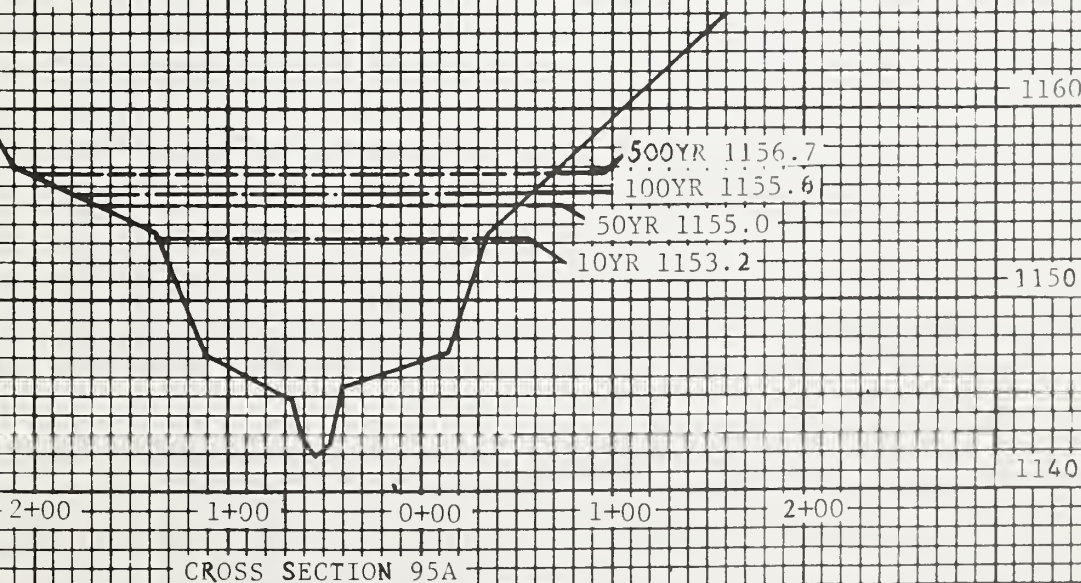
TYPICAL CROSS SECTIONS
PLEASANT RUN
ROCKINGHAM COUNTY, VA.
